Access Audit

The Redeemer Church of England Primary School

**Jack Walker Way
Fernhurst Farm,
Blackburn
BB4 4JJ**

21st January 2022

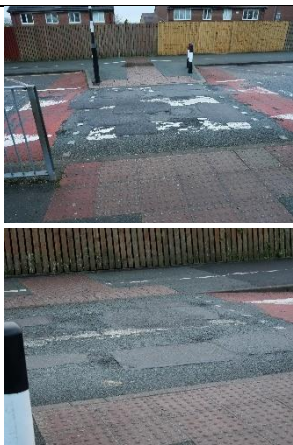
There are 2 zebra crossings located to the North and South of the school frontage, which are raised to footpath level. The alternate black and white ground markings are extremely worn and require remarking which is the responsibility of the Highway Authority.	Report the worn zebra crossing marking to Blackburn with Darwen Borough Council - https://www.blackburn.gov.uk/roads-and-highways/roads-report-problems	High

1. Report the worn zebra crossing markings to Blackburn with Darwen Borough Council. (Item 5.2)
2. Provide a contrasting band of 150mm to the top of all low-level bollards. (Item 5.3)

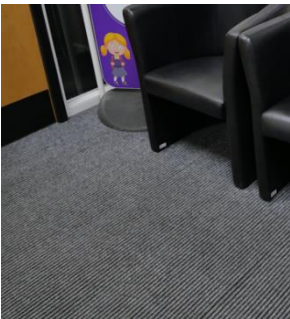
<p>space will provide a waiting area, clear of the route through.</p> <p>Upon entering through the double doors, entrance matting is provided to remove water from footwear and wheels to reduce the risk of wet slippery floors internally.</p> <p>A reception window is located in the lobby and electronic signing in is provided. The height adjuster on the arm on the sign in screen is restricted by cable ties, which are securing cables.</p> <p>No induction loop is provided at reception. An induction loop improves sound for hearing aid users and should be provided at reception areas, with a sign to indicate. They can be installed or portable.</p>	<p>None</p> <p>Alter the cable ties to allow height adjustment of the sign in screen.</p> <p>Provide an induction loop and provide signage</p>	<p>N/A</p> <p>High</p> <p>Medium</p>

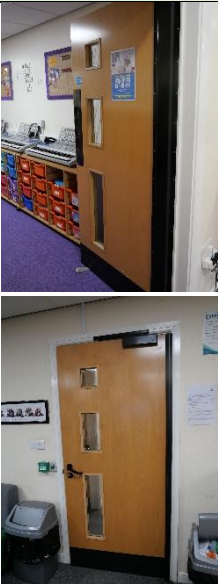
All internal doors have a clear width of 800mm, contrasting ironmongery, vision panels, hinge guarding and contrast well with the walls.	None	N/A
7.2 Corridors and Passageways

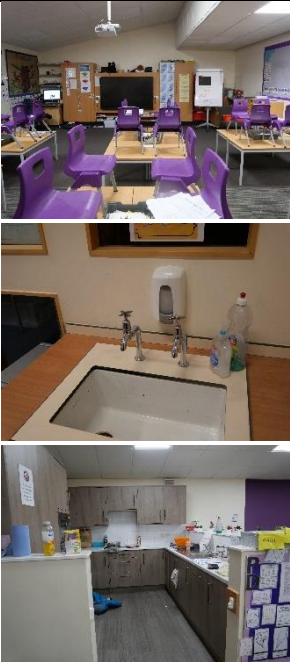
<p>Most rooms have sinks or a kitchen area, set in standard height worktops. Lever taps, which can be operated with a closed fist are required for people with limited manual dexterity. Lowered worktops with space under are required for wheelchair users. These are for staff use, reasonable adjustments for employees will be required.</p>	<p>Make reasonable adjustments as required.</p>	<p>As required</p>
